# **Appendix D**

## **Anomaly, Failure and Mishap Reporting**

No.	ID	Title	Status
1.	AMS-02-A01	HV Board Interconnect Failure.	Closed
2.	AMS-02-A02	Uninterruptible Power Supply FET Cracked	Closed
3.	AMS-02-A03	Improper Torquing of ECAL Fasteners	Closed
4.	AMS-02-A04	Anomaly of Thermal Conductor of AMS Internal Tracker	Closed

## Modifications of ECAL, RICH and TOF High Voltage Power Supply QM design

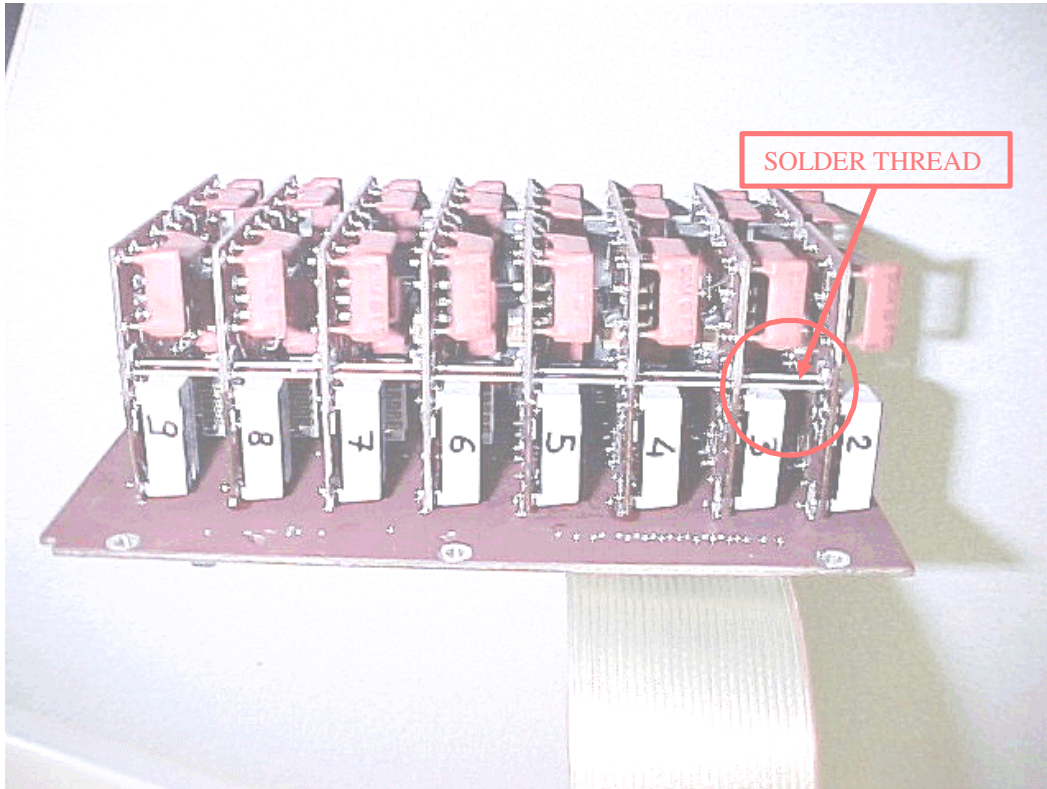
Picture 1 – side view of TOF Linear Regulator.

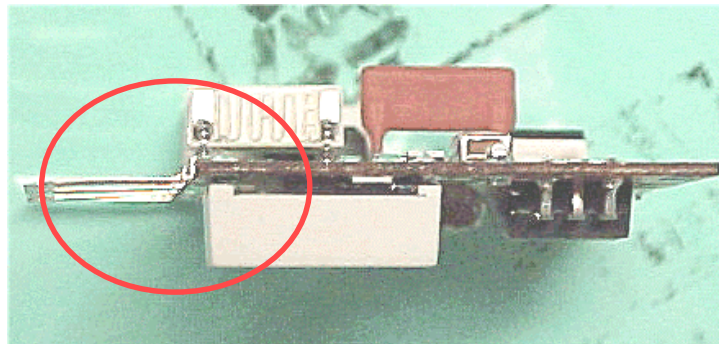
In the QM1, the *fork pins* had a straight shape, so that no strain relief was foreseen.

Picture 2 – View of the single regulator mini board with closeup of the straight pins used for the soldering of this component with the Linear Regulator main board.

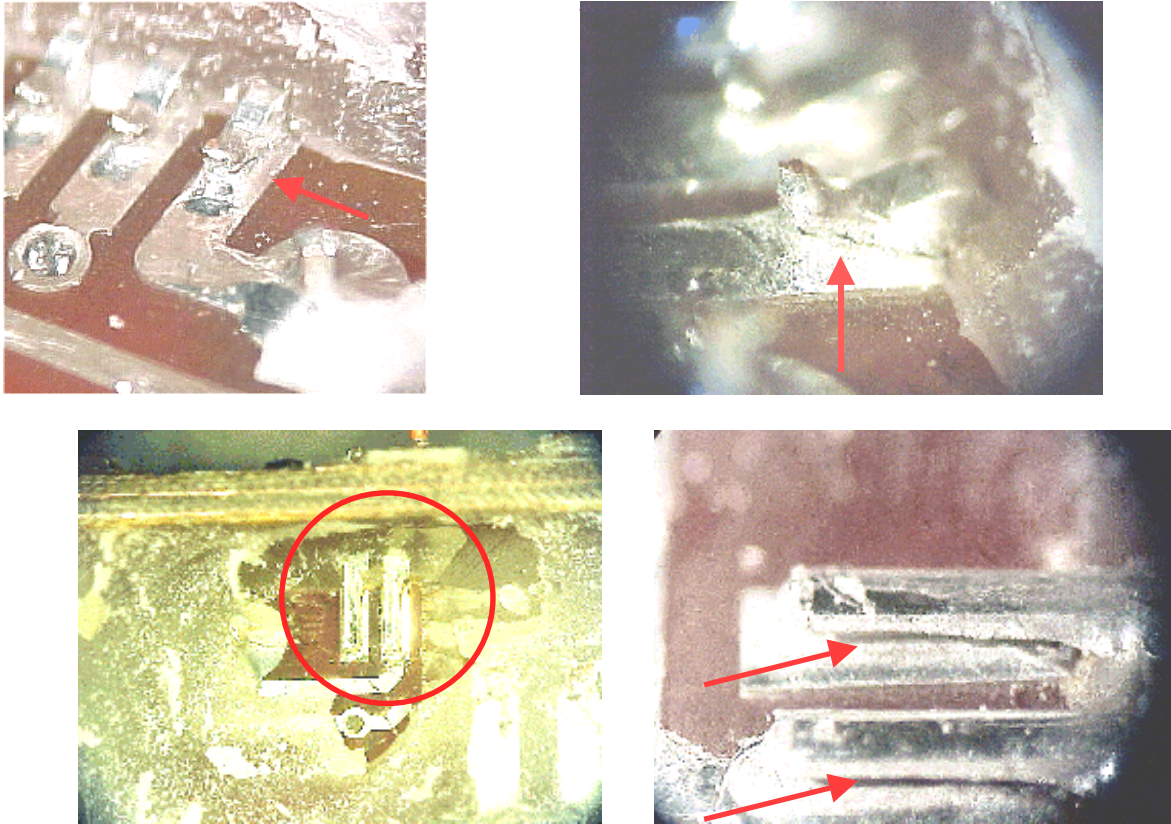
To investigate the problem, the TOF *brick* was dismantled and the Linear Regulators were carefully inspected. As a result, some of the SMD soldering of the straight pins were found to be broken, as shown in figure 3. According to CAEN, the failures were due to different thermal coefficient between resin and soldering material, generating a stress able to cause the connection rupture.

Figure 3 – Pictures of the pads where the *fork pins* were soldered.

To solve the problem, CAEN suggested to modify the pin shape.

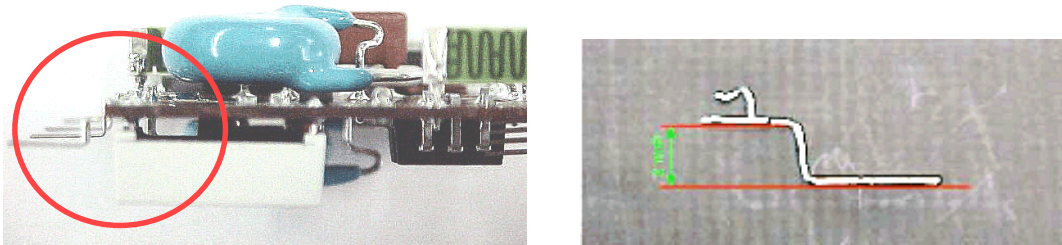
Figure 1 – New mini board with preformed pins(left). New shape of *fork pins* (right).

The CAEN proposal for the new pin shape is shown in figures 4 and 5. With this new shape, the pins should act as a strain relief and decrease the stress generated on the soldering pads by the thermal expansion.

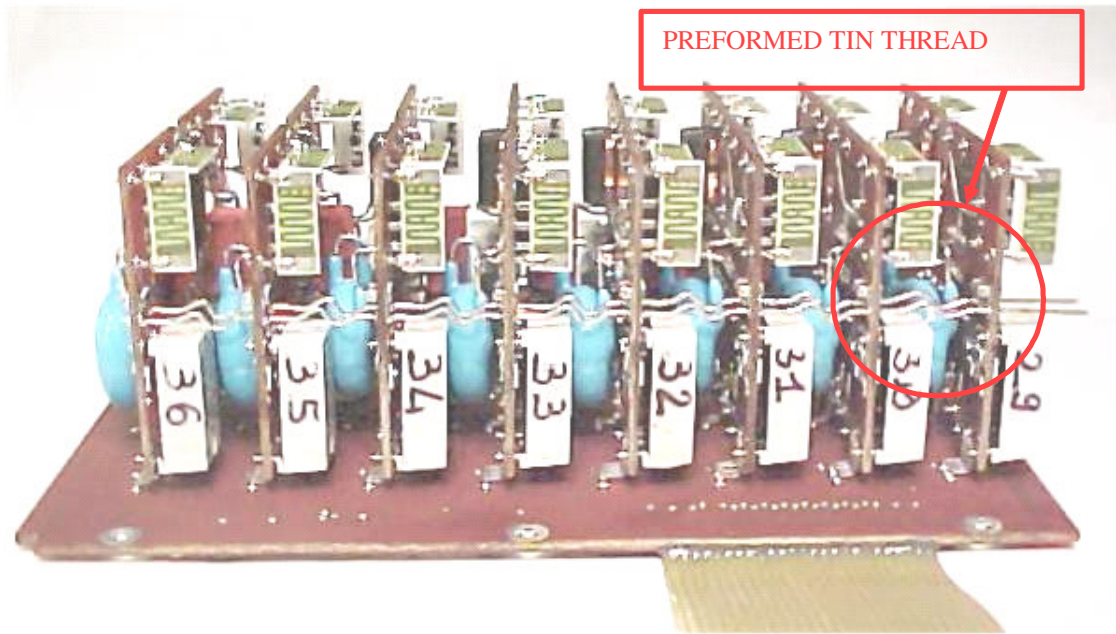
Figure 5

– QM2 test board. Also the interconnection thread has been preformed.

A test board has been constructed and tested at CAEN as follows:

1. burn-in for 8 hours with a temperature of 70°C ;
2. thermo-vacuum test with pressure of 0.1mBar, verifying the absence of discharges ;
3. thermal cycles (10 cycles in total between -30°C and +70°C, with a ramp-up rate of 4°C/min, down-ramp rate of 2°C/min and time of permanence at each temperature of 1 hour).

At the end of each cycle, all the channels were inspected. No problem was observed.

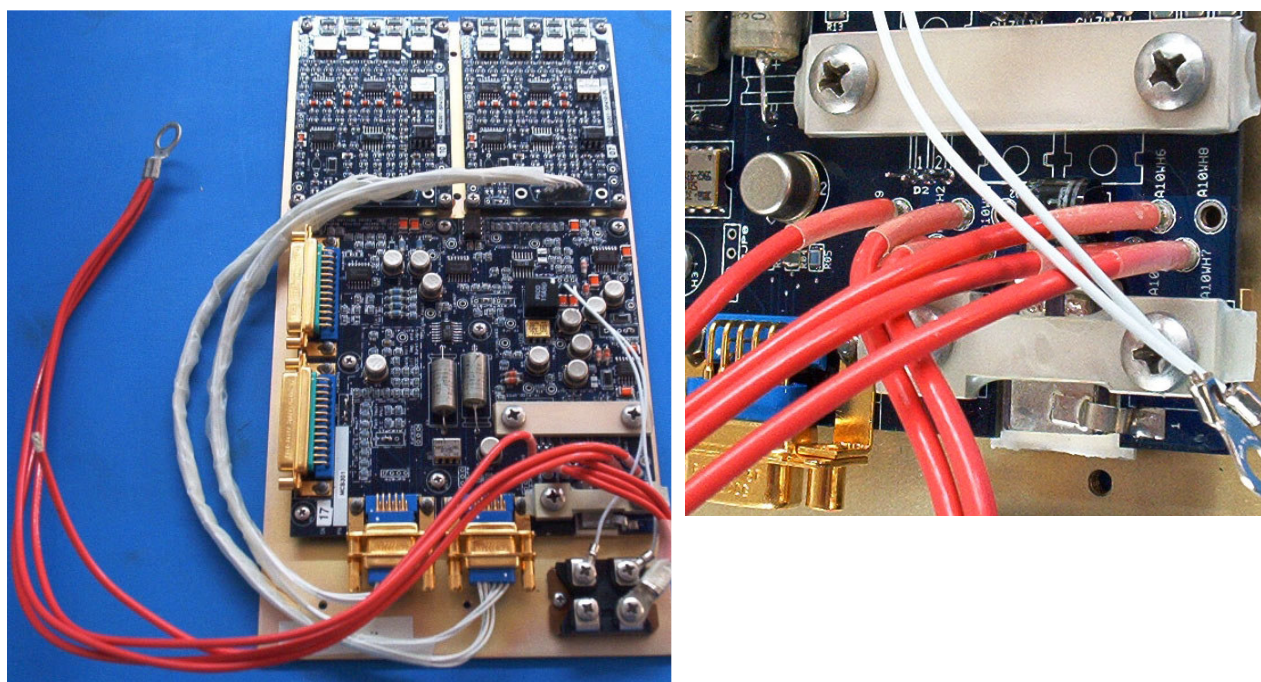
**Description of Event:** During the final system testing of the full electronics assembly at Eaves Devices, the last board (5<sup>th</sup> out of 5) tested failed the current interruption test (support 77A for 360ms to 1500ms). Upon examination of the board, it was discovered that the FET was cracked under the compression bar holding it in contact with the heat sink. These cracks apparently shorted the device, causing it to fail under high current. As shown in the attached pictures, the FET (located in the front right of the AMS BMS picture, near all the big red wires) has a compression bar over the top of it, holding it in contact with two layers of SIL-PAD and an aluminum heat sink. Per Eaves Devices assembly procedures, the screws on this compression bar are only torqued to 6 in-lbs.

Further examination of the other 4 boards revealed that the FETs in those boards showed signs of cracking, but had not failed any testing.

**Corrective Action:** Compression bar was eliminated from the design and a thermally conductive adhesive was used. Material usage was approved by JSC Materials. Thermal performance and board function were retested and found acceptable.

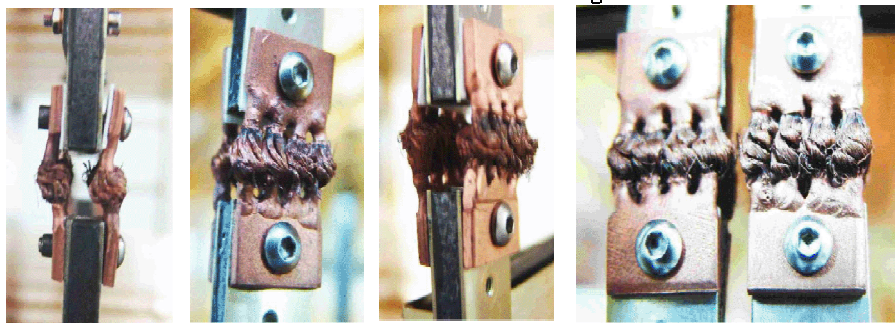
This compression was performed *in situ* during assembly of the 3 planes of the inner tracker but before the definitive connexion. Some braids were damaged:

- Some weakness of the metal properties might have been introduced by the welding of the Copper braids
- The effect on thermal conductivity is negligible.
- The damaged threads showed a single break.
- No one was found to be loose.

**Actions taken:** Study of a containment procedure of the Copper braids using space qualified heat shrink tubing (*See Appendix B*). This tubing must be installed *in situ* after vacuum cleaning of the braids with examination of the filter. The heating should not damage the electronics.

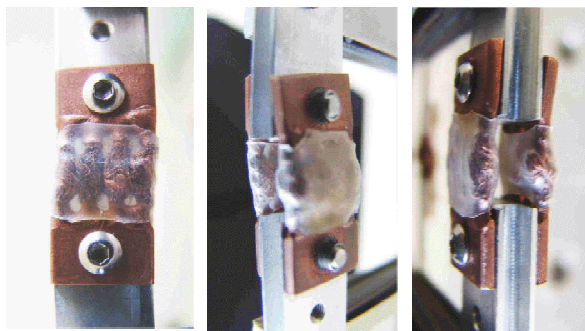
We studied the use of Kynar heat shrink tubing (space qualified) to enclose the Copper braids. Preliminary tests on prototypes are shown below:

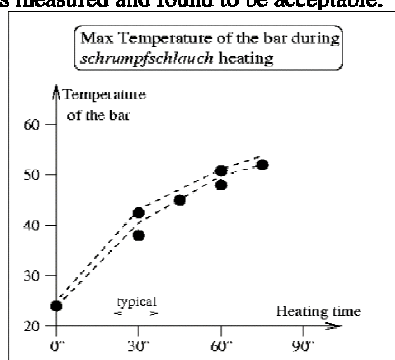
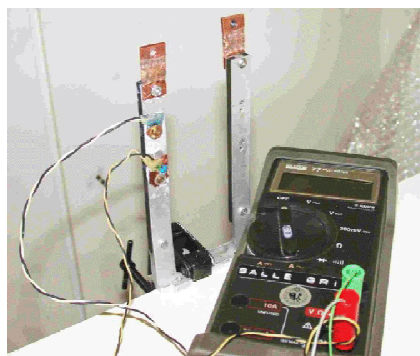
The tube is heated during ~ 30 seconds. The effect on the temperature of electronic hybrid circuits was measured and found to be acceptable:

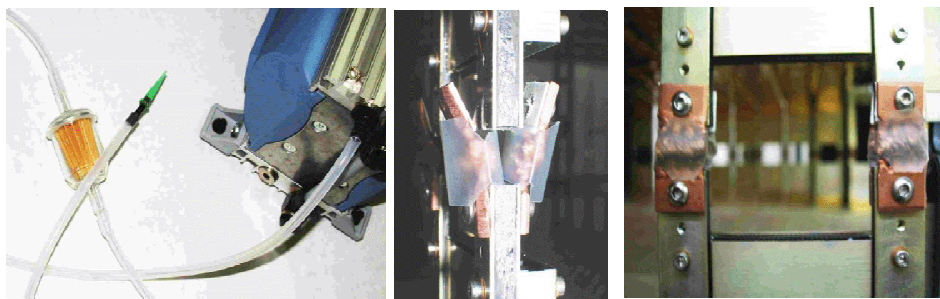
A procedure was established and was applied on all thermal connectors. A preliminary cleaning was made with a micro vacuum cleaner. The filter was examined. No broken thread was found in the filter.
